CERCLA Expanded Site Inspection Report

Bautsch-Gray Mine
ILN 000508088
Galena, Illinois

Prepared by:
Illinois Environmental Protection Agency
Bureau of Land
Division of Remediation Management
Office of Site Evaluation

April 30, 2010

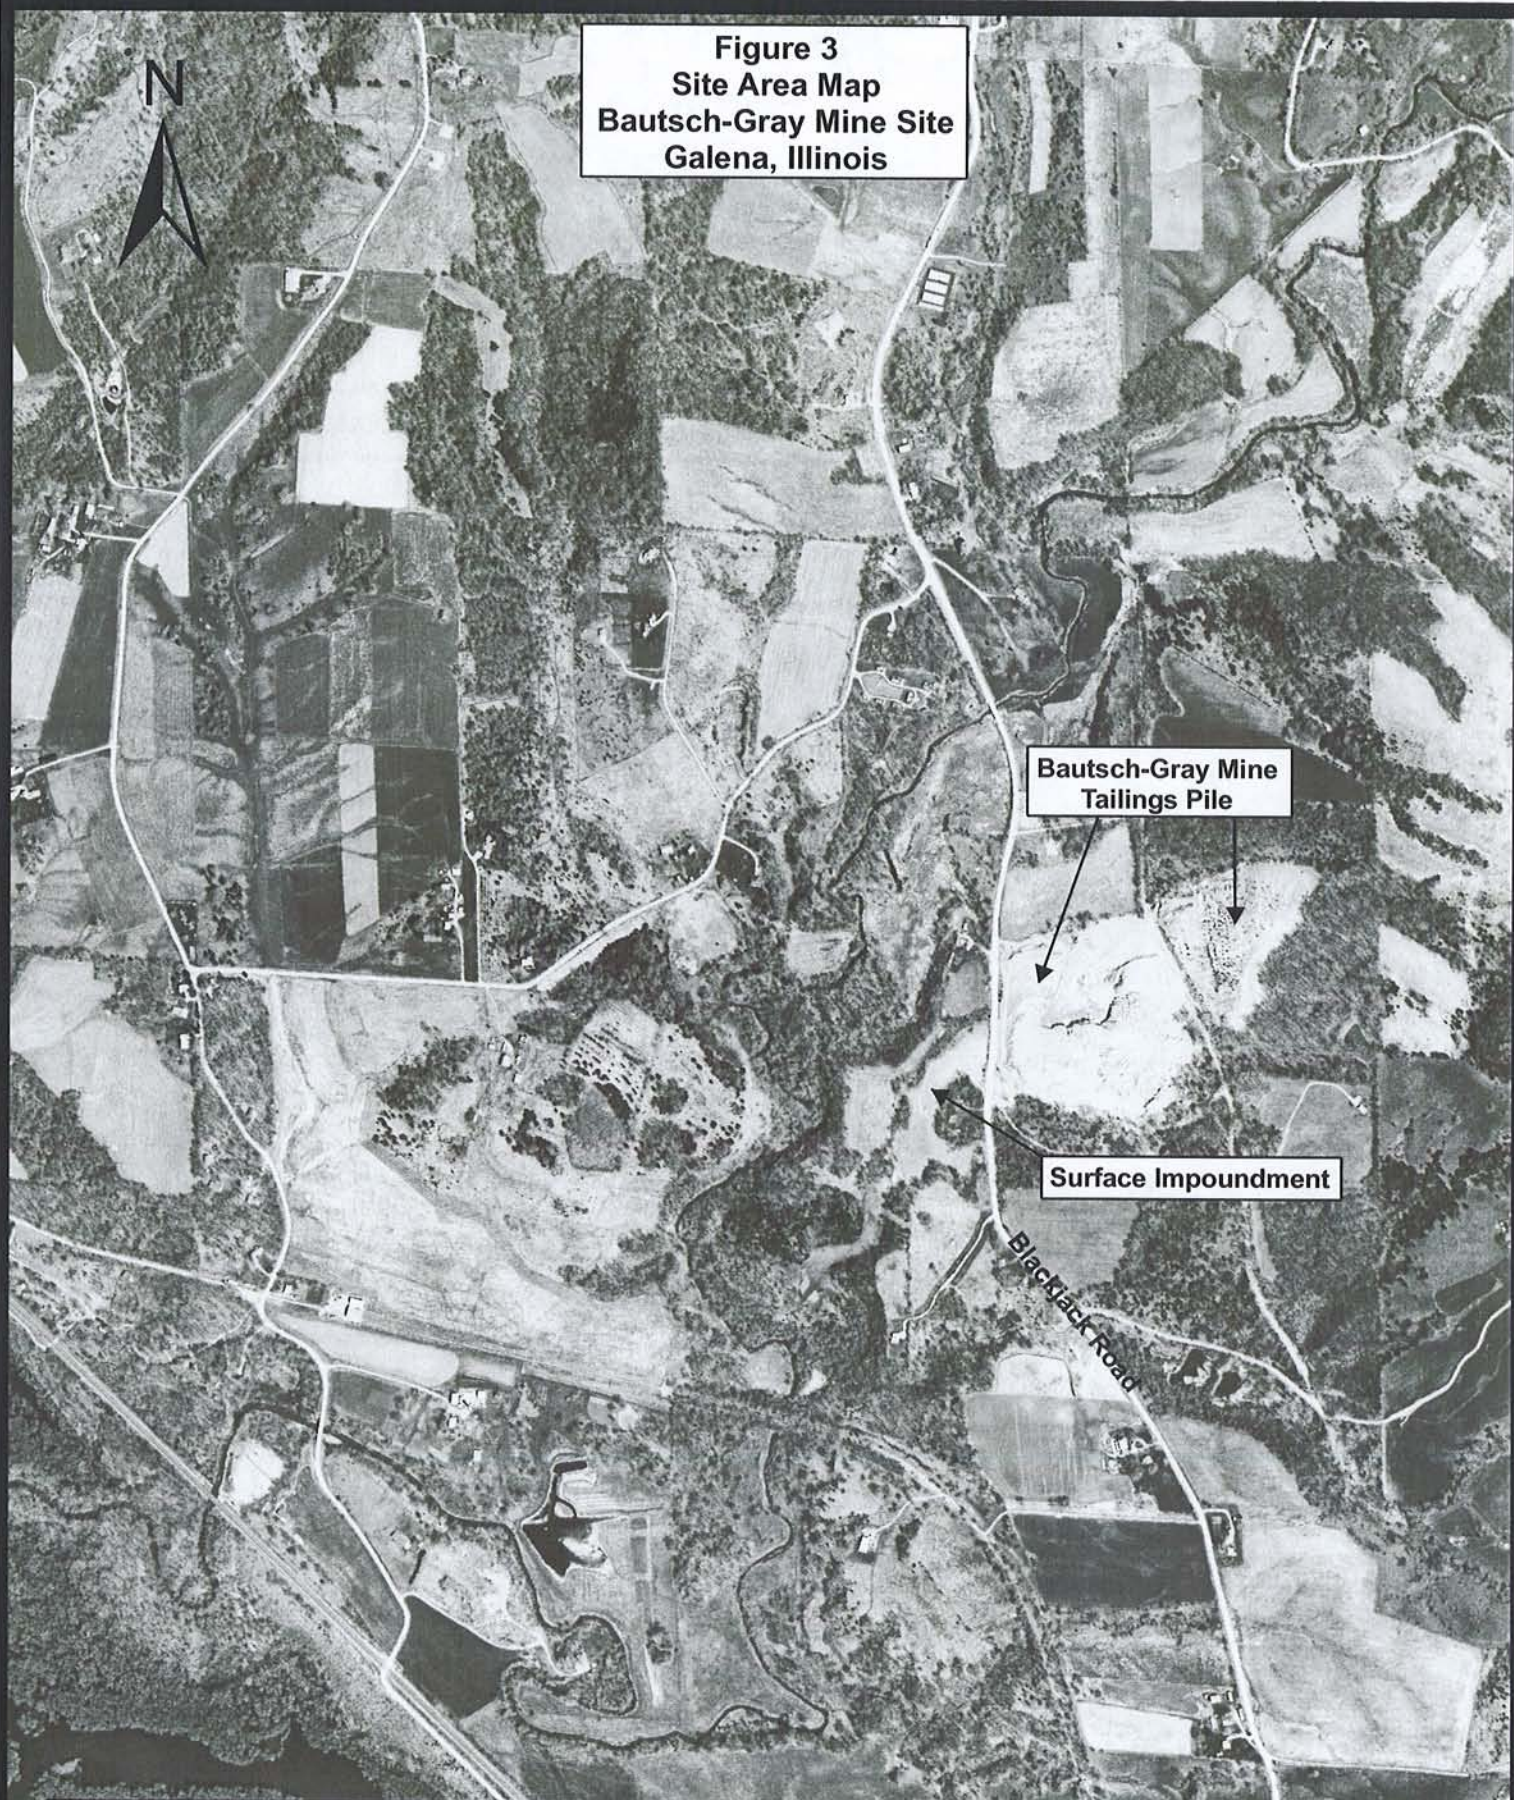
Figure 3
Site Area Map
Bautsch-Gray Mine Site
Galena, Illinois

West of the tailings pile is a horse-shoe shaped settling pond. Illustrated in Figures 2 and 3, the settling pond consists of mine tailings that apparently have washed off of the large tailings pile to its east. It is estimated that tailings material in the settling pond varies between 4 and 20 feet in thickness. The settling pond is non-vegetated, except for a small area where cattails are growing located in the southeast corner. One residential dwelling, located west of Blackjack Road, is located on an outcropping of land that is less than 200 feet from the north, west and south sides of the settling pond. According to National Wetlands Inventory Map constructed by the United States Department of the Interior the settling pond is a Paulistrine, unconsolidated bottom, semi-permanently flooded wetland and is illustrated in Figure 4.

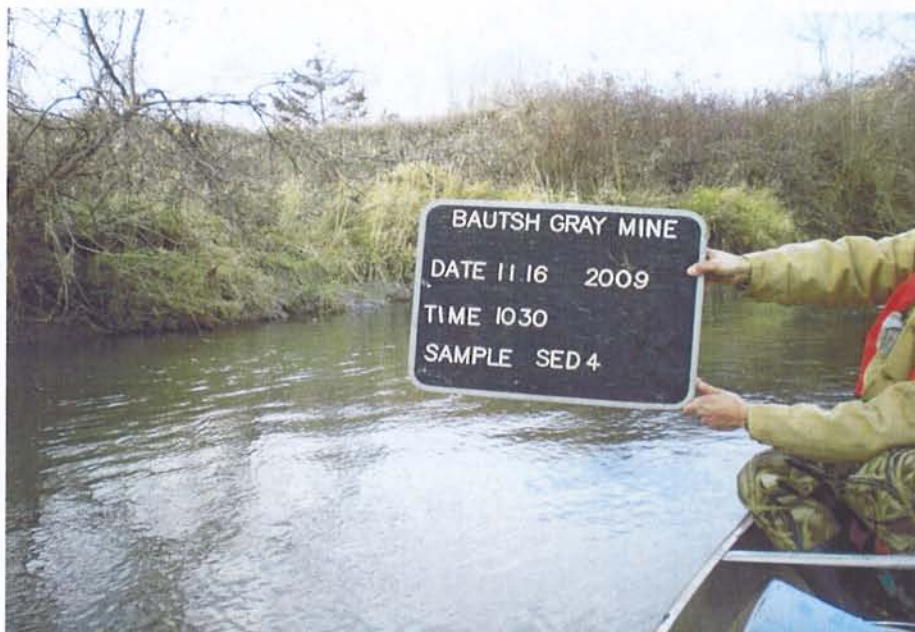
DATE: November 16, 2009
TIME: 1030
PHOTO BY: B. Everetts
DIRECTION: Southeast
COMMENTS: Photo taken of Sediment Location #4 from which sediment sample X210 was collected. Sample X210 was taken from 6 - 12 inches within the sediments and below approximately 2.5 feet of water.

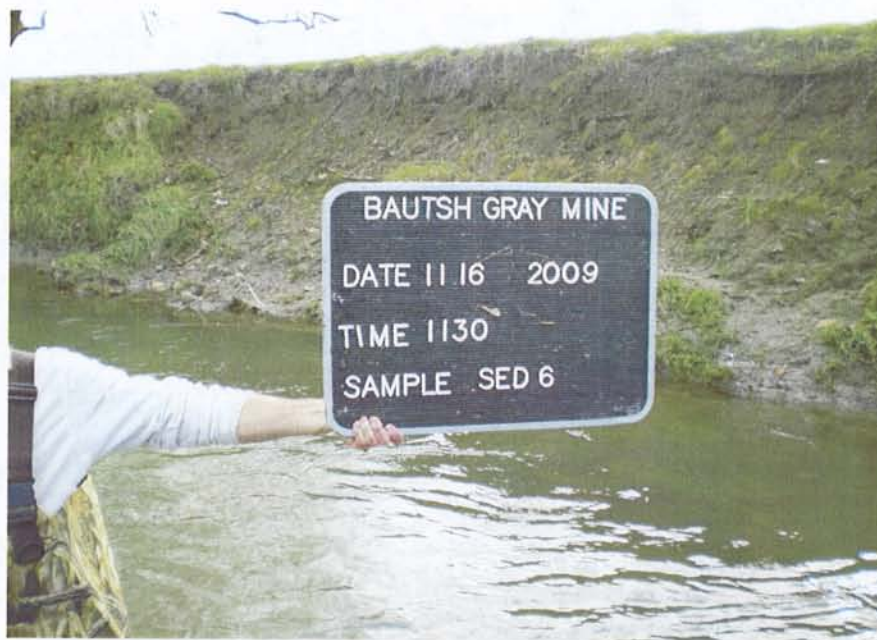
DATE: November 16, 2009
TIME: 1130
PHOTO BY: B. Everetts
DIRECTION: East
COMMENTS: Photo taken of Sediment Location #6 from which sediment sample X208 was collected. Sample X208 was taken from 0 - 6 inches within the sediments and below approximately 2 feet of water.

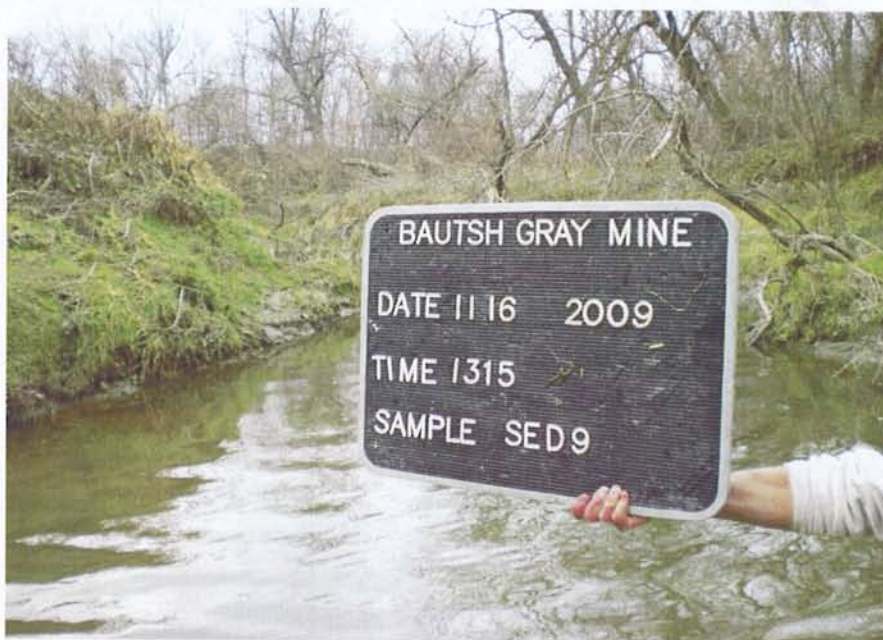
DATE: November 16, 2009
TIME: 1315
PHOTO BY: B. Everetts
DIRECTION: North
COMMENTS: Photo taken of Sediment Location #9 from which sediment sample X207 was collected. Sample X207 was taken from 0 - 6 inches within the sediments and below approximately 2 feet of water.

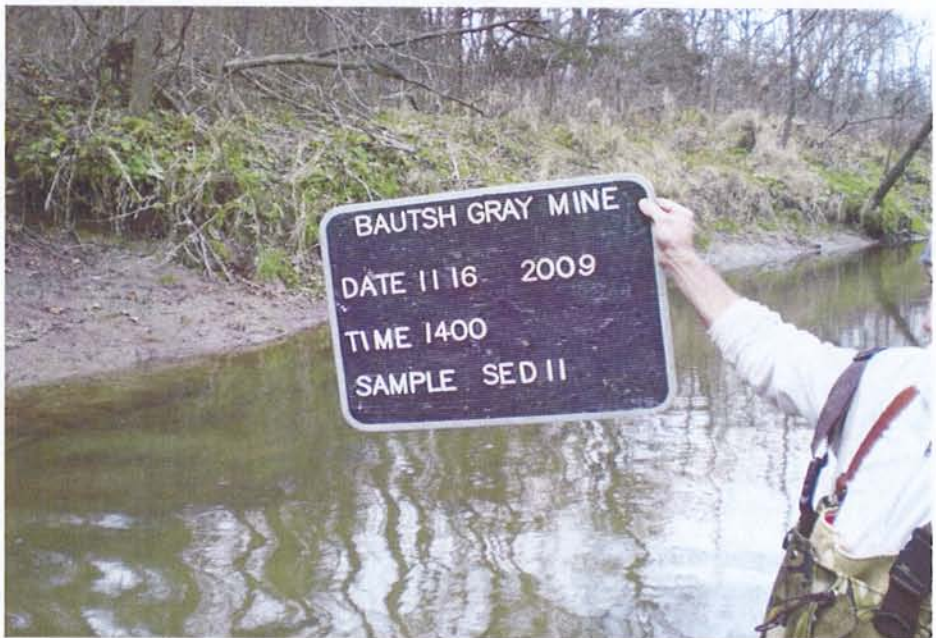
Photo taken of Sediment Location #11 from which sediment sample X205 was collected. Sample X205 was taken from 6 - 12 inches within the sediment and below approximately 1.5 feet of water.

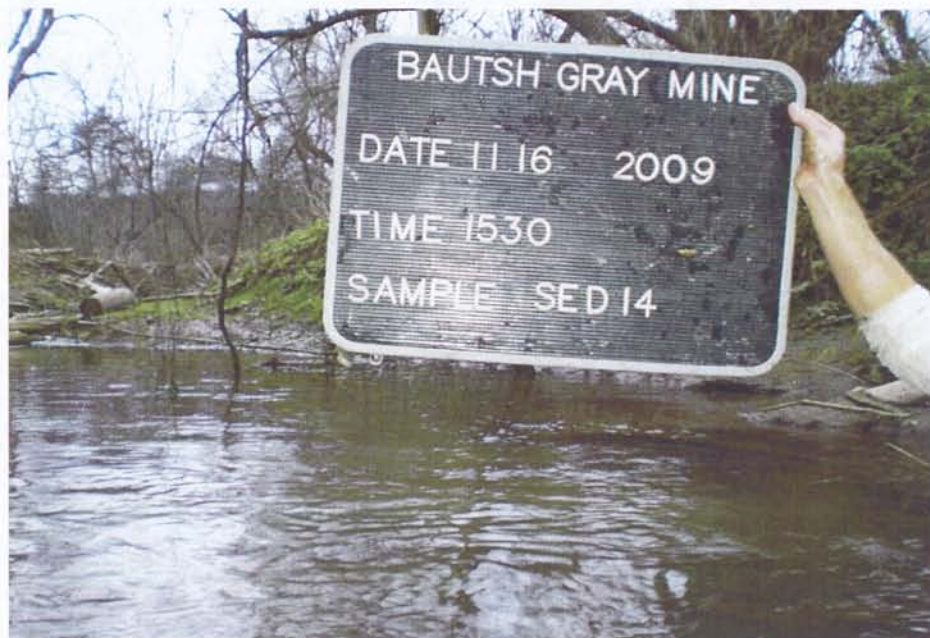
DATE: November 16, 2009
TIME: 1530
PHOTO BY: B. Everetts
DIRECTION: East
COMMENTS: Photo taken of Sediment Location #14 from which sediment sample X203 was collected. Sample X203 was taken from 12 - 24 inches within the sediment and below approximately 3 feet of water.

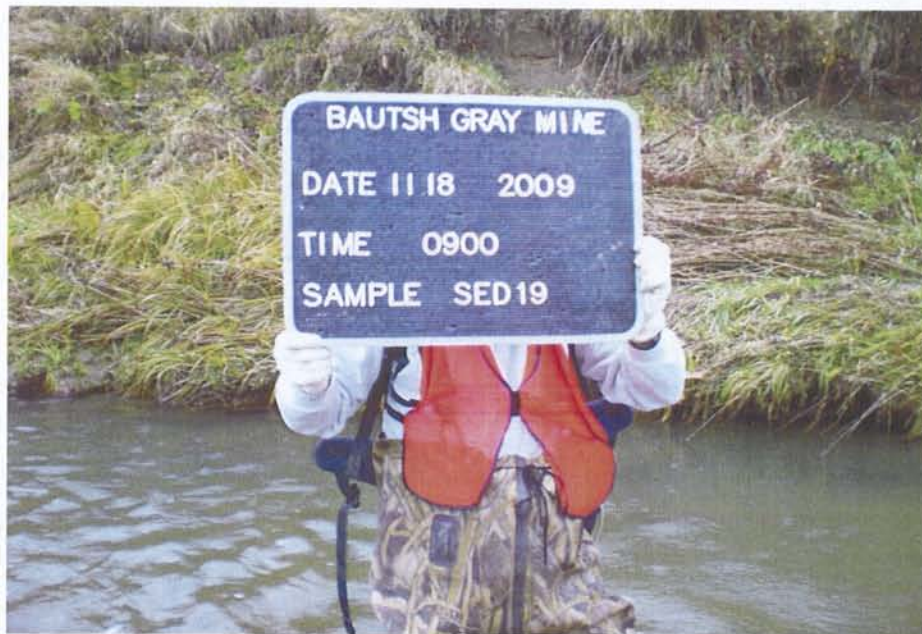
DATE: November 18, 2009
TIME: 0900
PHOTO BY: B. Everetts
DIRECTION: Northwest
COMMENTS: Photo taken of Sediment Location #19 from which sediment sample X202 was collected. Sample X202 was taken from 0 - 6 inches within the sediment and below approximately 2 feet of water.

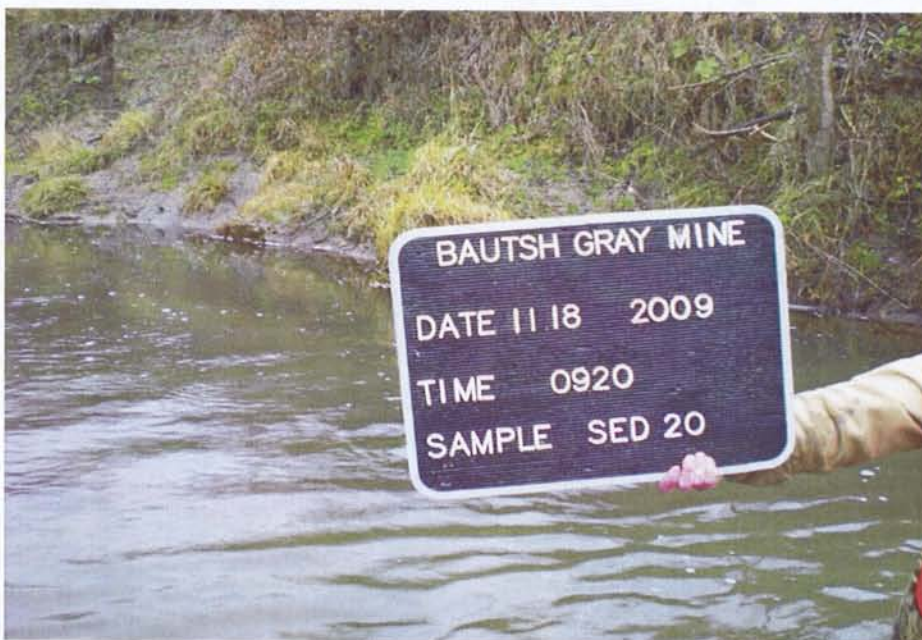
DATE: November 18, 2009
TIME: 0920
PHOTO BY: B. Everetts
DIRECTION: Southwest
COMMENTS: Photo taken of Sediment Location #20 from which sediment samples X201-A and X201-B were collected. Sample X201-A was taken from 0 - 6 inches and X201-B was taken from 6 - 12 inches within the sediments. Both samples were collected beneath approximately 1.5 feet of water.

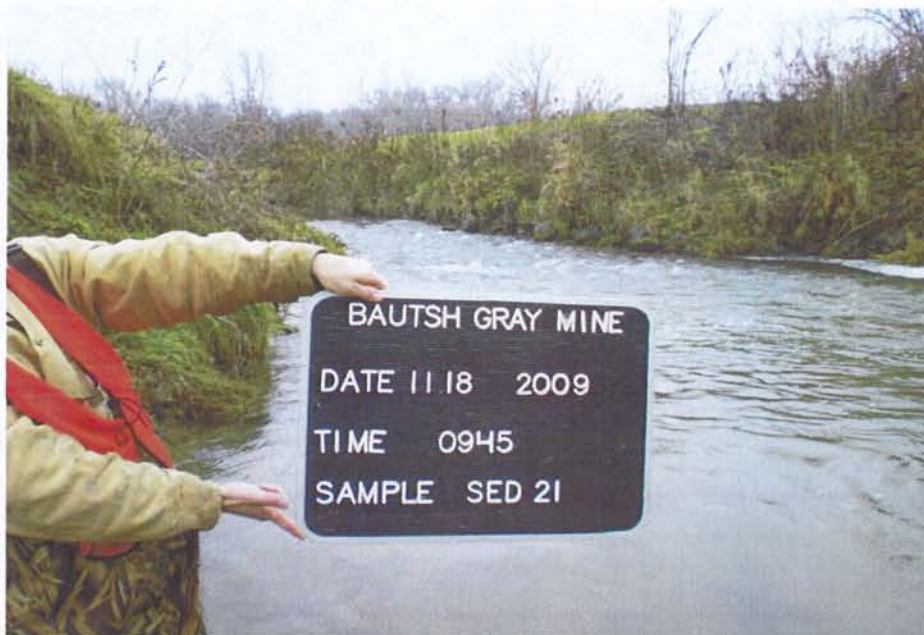
Photo taken of Sediment Location #21 from which sediment sample X200 was collected. Sample X200 was taken from 6 - 12 inches within the sediments and below approximately 1.5 feet of water.

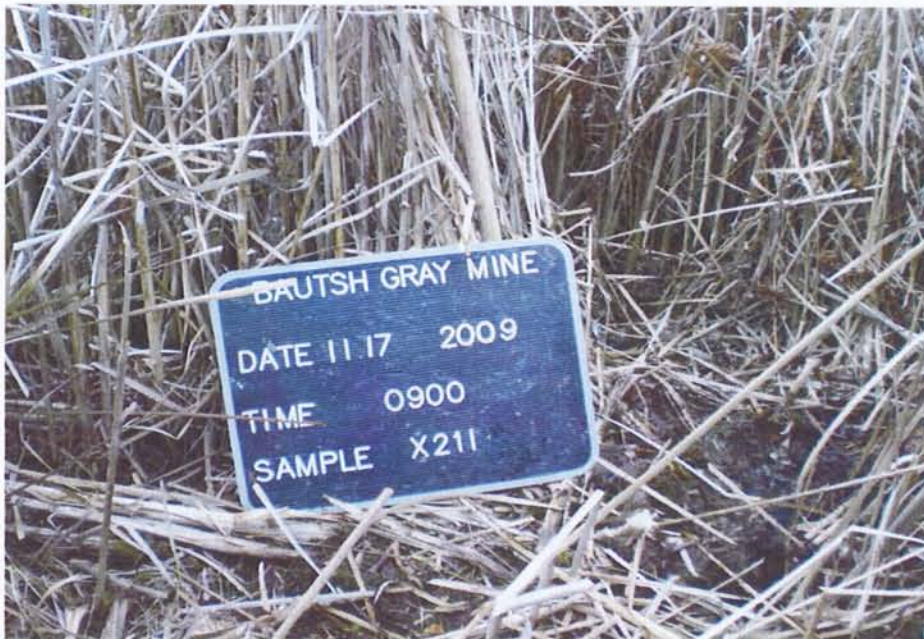
Samples X211 through X214 represent sediment sample locations collected from the wetland located northwest of the Bautsch-Gray Mine tailings pile. In three of the four samples, only zinc was detected at levels met the observed release criteria. The

Photo taken of sediment sample X211 which was collected from the wetland located northwest of the Bautsch-Gray Mine Site.

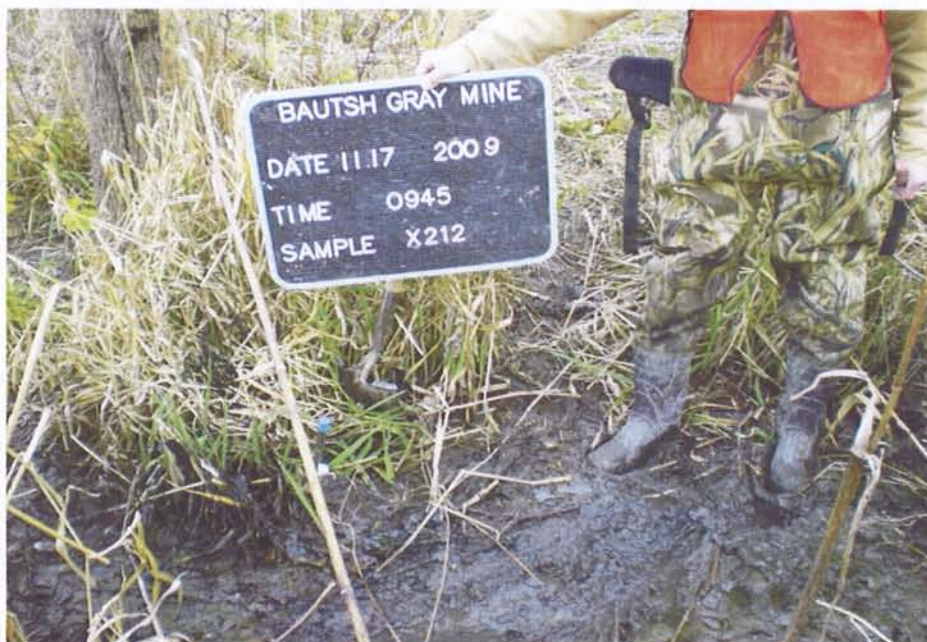
Photo taken of sediment sample X212 which was collected from the wetland located northwest of the Bautsch-Gray Mine Site.

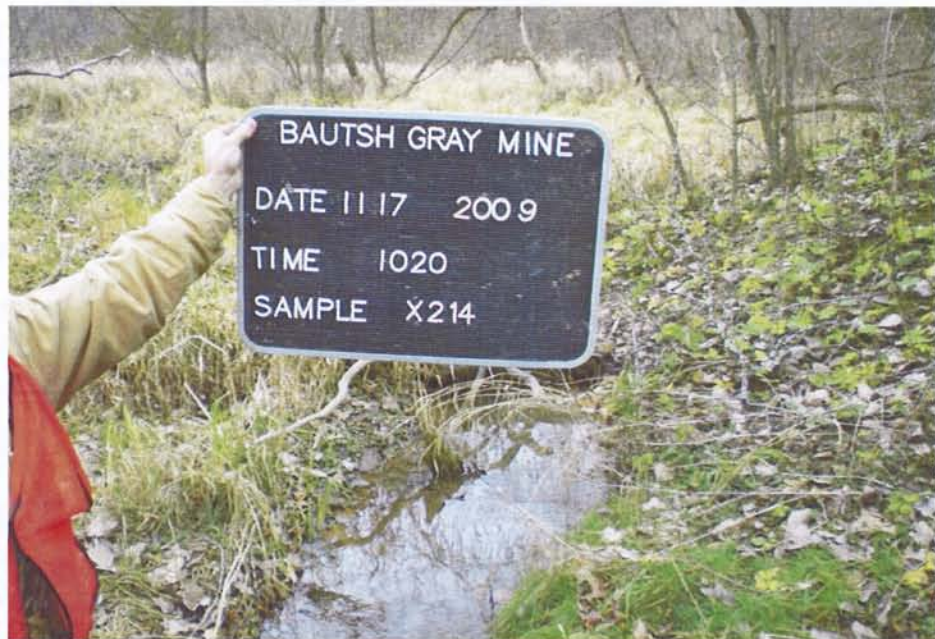
DATE: November 17, 2009
TIME: 1020
PHOTO BY: B. Everetts
DIRECTION: South
COMMENTS: Photo taken of sediment sample X214 which was collected from the wetland located northwest of the Bautsch-Gray Mine Site.

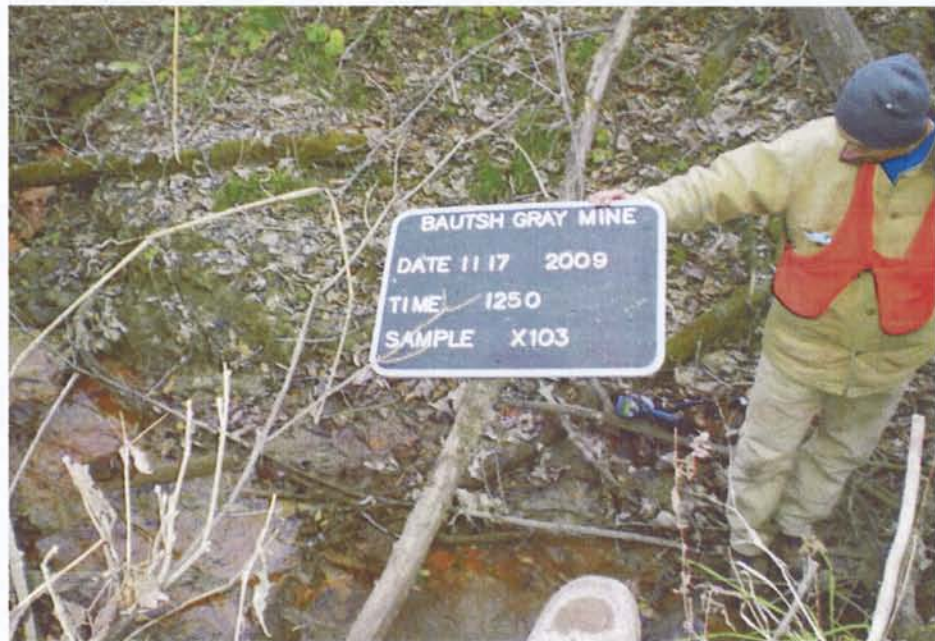
The analysis of soil samples X103 through X108 indicated that inorganic contamination was present along the overland flow route. Once past the surface impoundment, lead, zinc, arsenic, cadmium, and copper were detected at levels that met the observed release criteria. Their attribution can be linked to up-gradient sources, specifically the surface impoundment and tailings pile. The results of the samples were compared to background soil samples X101 and X102. A summary of the laboratory samples can be found in Table 4.

DATE: November 17, 2009
TIME: 1250
PHOTO BY: B. Everetts
DIRECTION: South
COMMENTS: Photo taken of soil sample X103 which was located along the overland flow route leading from the surface impoundment to Smallpox Creek. This location is approximately 50 feet east of Smallpox Creek.

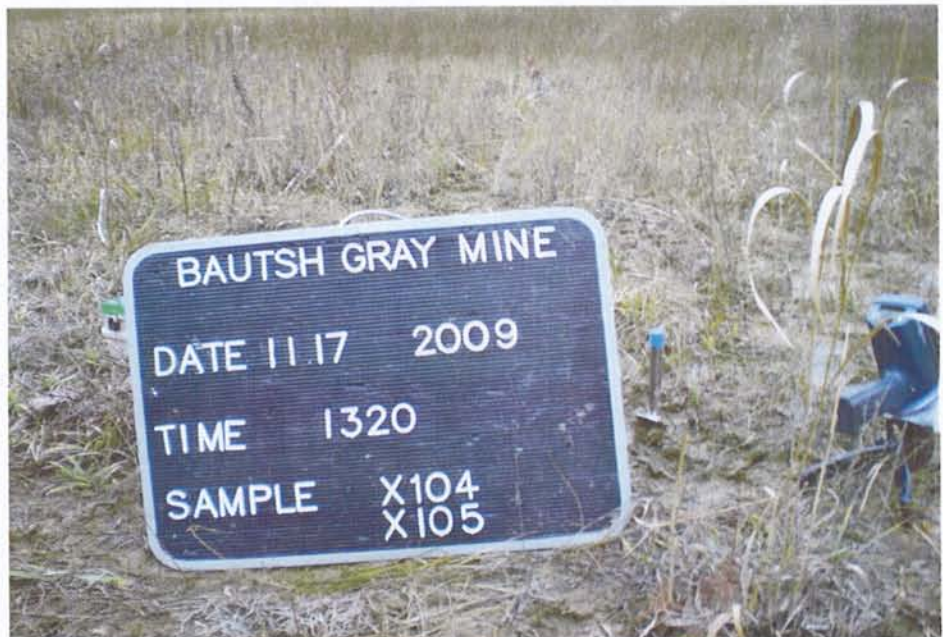
DATE: November 17, 2009
TIME: 1320
PHOTO BY: B. Everetts
DIRECTION: Southwest
COMMENTS: Photo taken of soil samples X104 and X105 which was collected along the overland flow route leading from the surface impoundment to Smallpox Creek. Sample X105 is a field duplicate of X104.

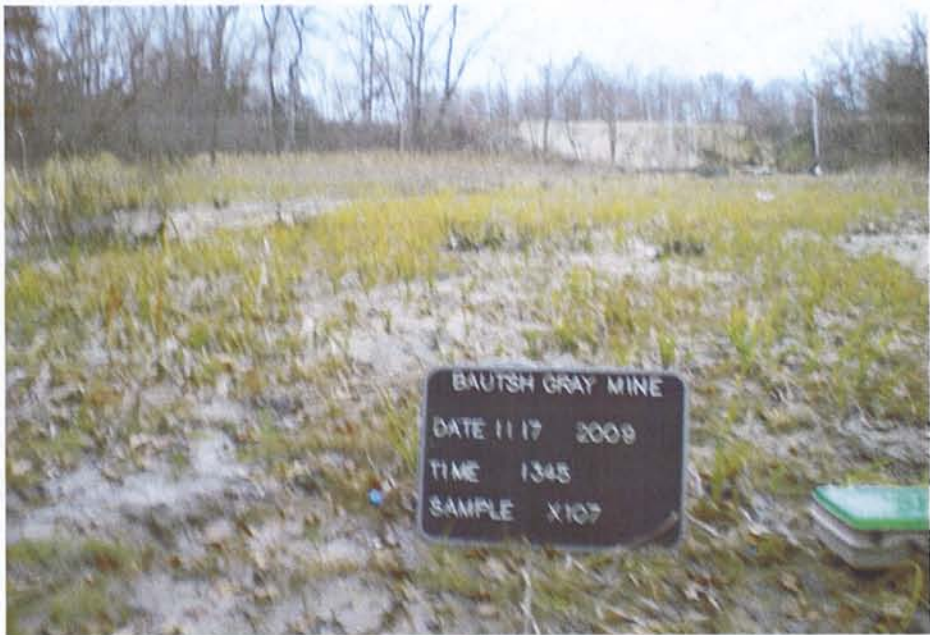
DATE: November 17, 2009
TIME: 1345
PHOTO BY: B. Everetts
DIRECTION: Northeast
COMMENTS: Photo taken of soil sample X107 which was collected from the overland flow route leading from the surface impoundment to Smallpox Creek. *note: the berm of the surface impoundment in the background.

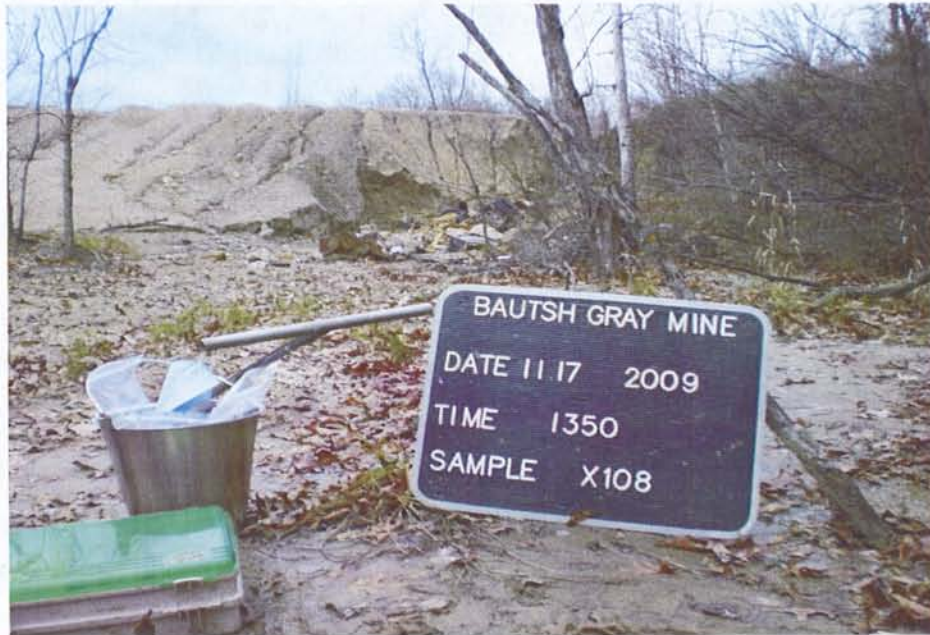
DATE: November 17, 2009
TIME: 1350
PHOTO BY: B. Everetts
DIRECTION: Northeast
COMMENTS: Photo taken of soil sample X108 which was collected from the overland flow route leading from the surface impoundment to Smallpox Creek. The berm of the surface impoundment can be seen in the background.

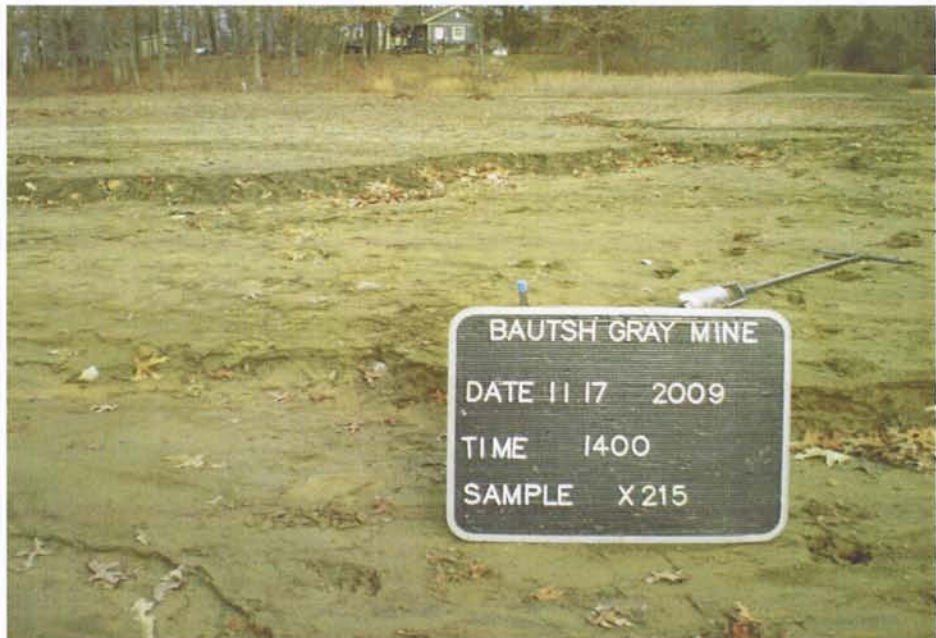
Samples X215 through X218 represent sample locations collected from the surface impoundment. When compared to background soil samples X101 and X102, each location contained levels of lead, zinc, arsenic, cadmium, and copper that met observed release criteria. The material in the surface impoundment was both physically and analytically similar to the up-gradient tailings pile and can be attributed to past mining activities. Table 3 contains a summary of the analytical results.

DATE: November 17, 2009
TIME: 1400
PHOTO BY: B. Everetts
DIRECTION: Southeast
COMMENTS: Photo taken of sediment sample X215 which was collected from the surface impoundment east of the Bautsch-Gray Mine waste pile.

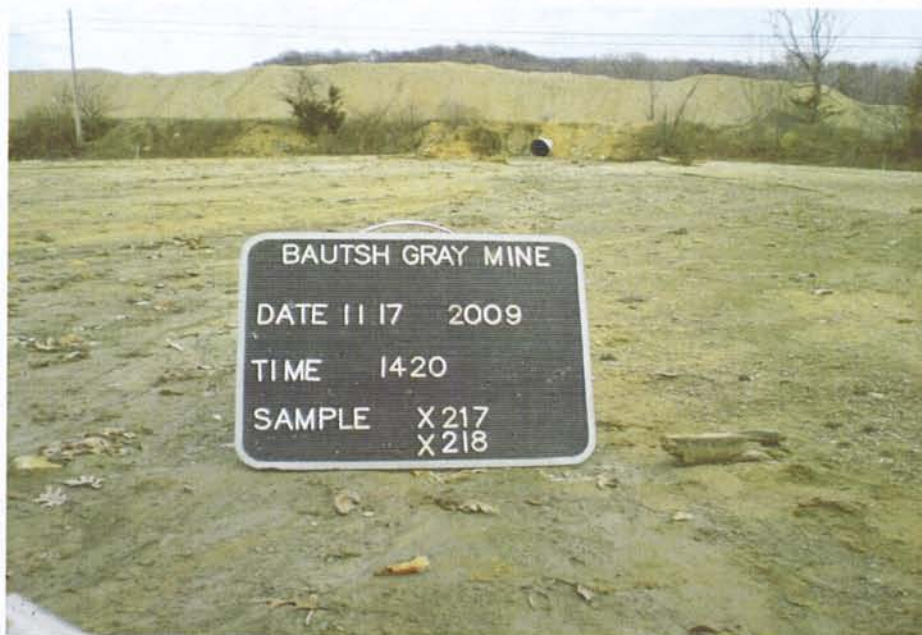
Photo taken of sediment samples X217 and X218 which was collected from the surface impoundment located east of the Bautsch-Gray Mine waste pile. The waste pile can be seen in the background. Sample X218 is a field duplicate of sample X217.

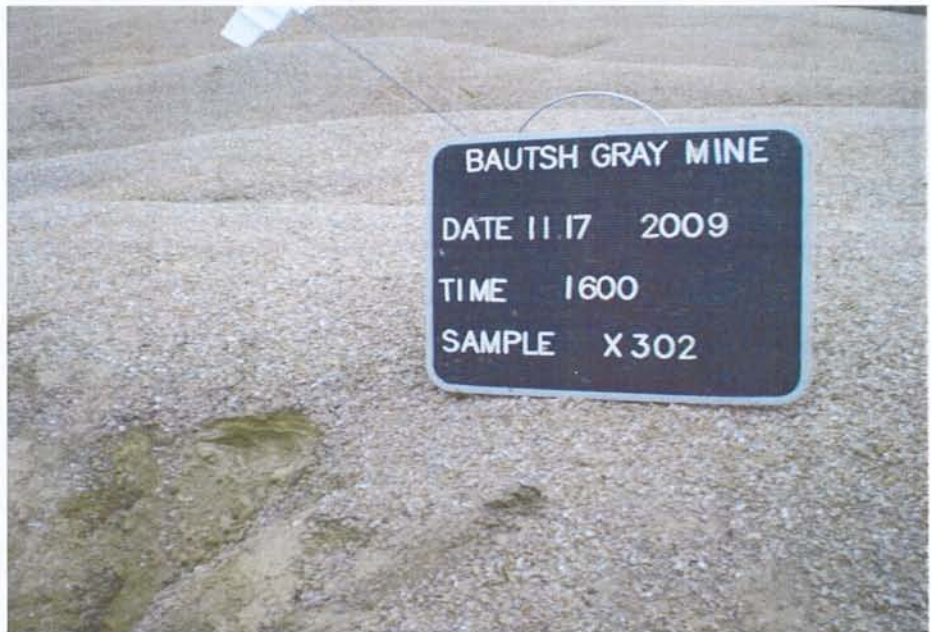
DATE: November 17, 2009
TIME: 1600
PHOTO BY: Jim Salch
DIRECTION: West
COMMENTS: Photo taken of Sample X302 which was collected from the southeastern portion of the waste pile.

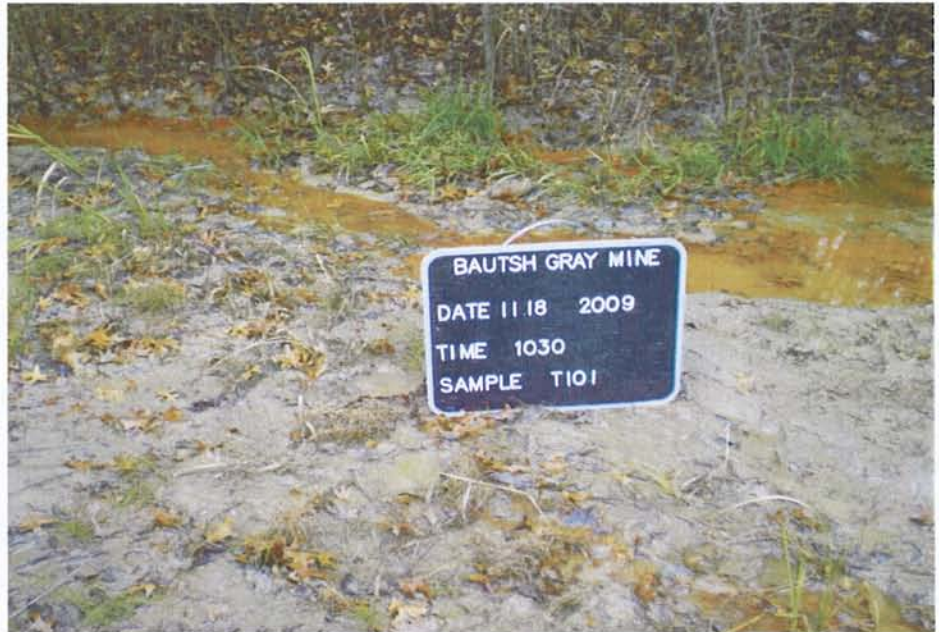
Three samples were collected and analyzed for TCLP metals. When compared to TCLP values set forth in Subtitle G of Title 35 of the Environmental Protection Act, all three locations exceeded values for lead. One location was chosen from the waste pile, surface impoundment, and the overland flow. Although TCLP data was not used to evaluate the Bautsch-Gray Mine Site for Hazard Ranking System purposes, this analytical information will assist state and/or federal programs in making site specific hazardous waste determinations. A summary of TCLP results can be found in Table 7.

DATE: November 18, 2009
TIME: 1030
PHOTO BY: B. Everetts
DIRECTION: North
COMMENTS: Photo taken of Sample T101 which was taken along the overland flow route leading from the surface impoundment to Smallpox Creek.

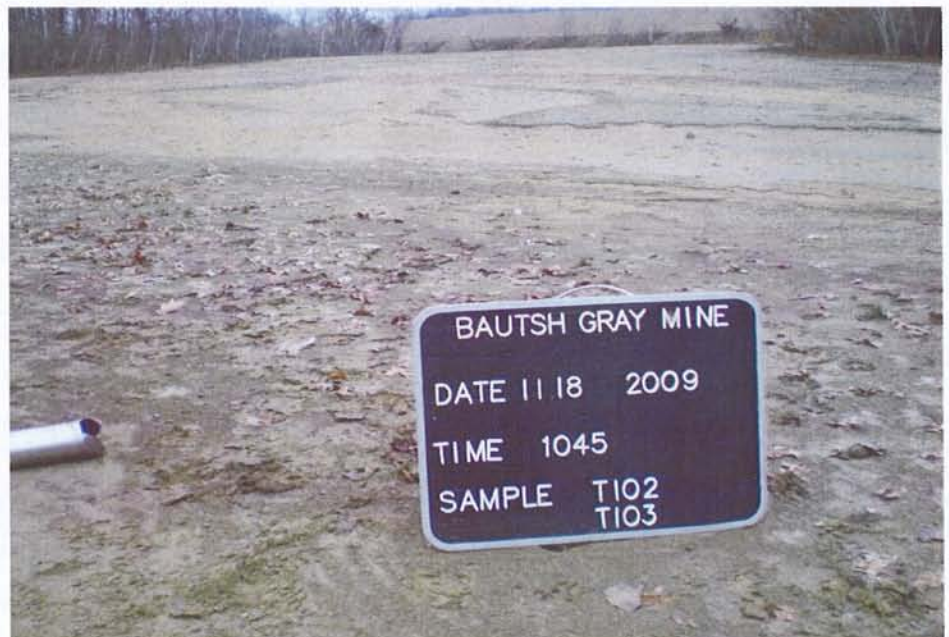
DATE: November 18, 2009
TIME: 1045
PHOTO BY: B. Everetts
DIRECTION: Northeast
COMMENTS: Photo taken of Sample T102 and T103 which was collected from the surface impoundment located west of the Bautsch-Gray Mine waste pile. Sample T103 is a field duplicate of Sample T102.

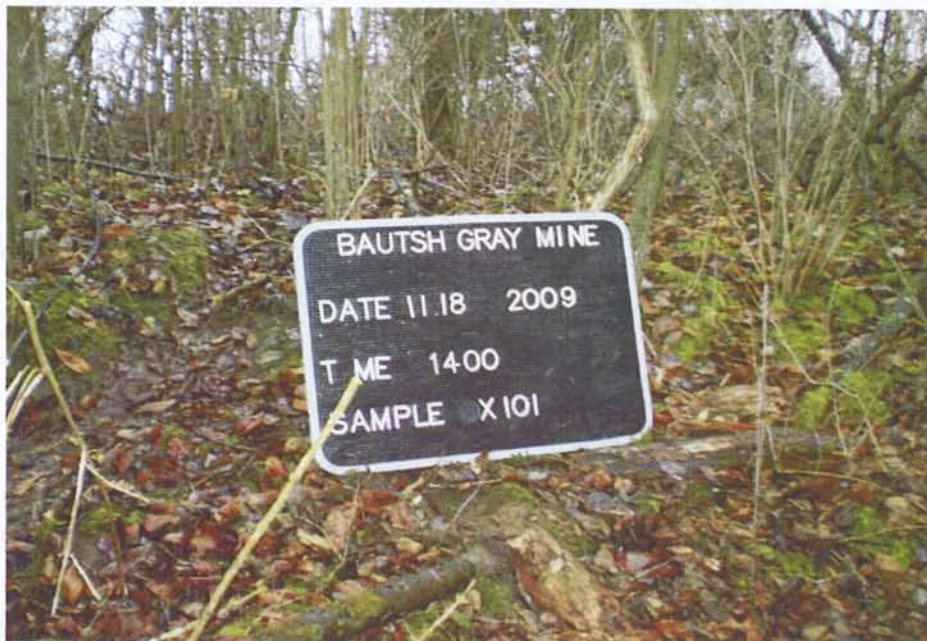
Samples X101 and X102 were taken for the purpose of establishing background soil conditions around the mine tailings area. Sample X101 was collected just to the south of the mine tailings pile while Sample X102 was collected just to the north. These

DATE: November 18, 2009
TIME: 1400
PHOTO BY: B. Everetts
DIRECTION: South
COMMENTS: Photo taken of Sample X101 which was collected from a wooded area just south of the waste pile.

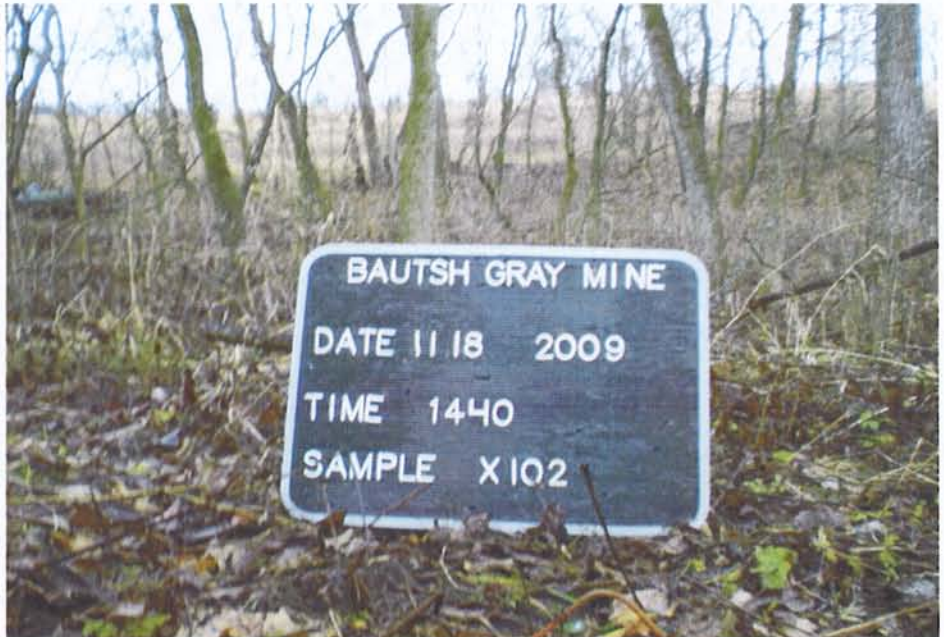
Photo taken of Sample X102 which was collected from a wooded area located just north of the waste pile.

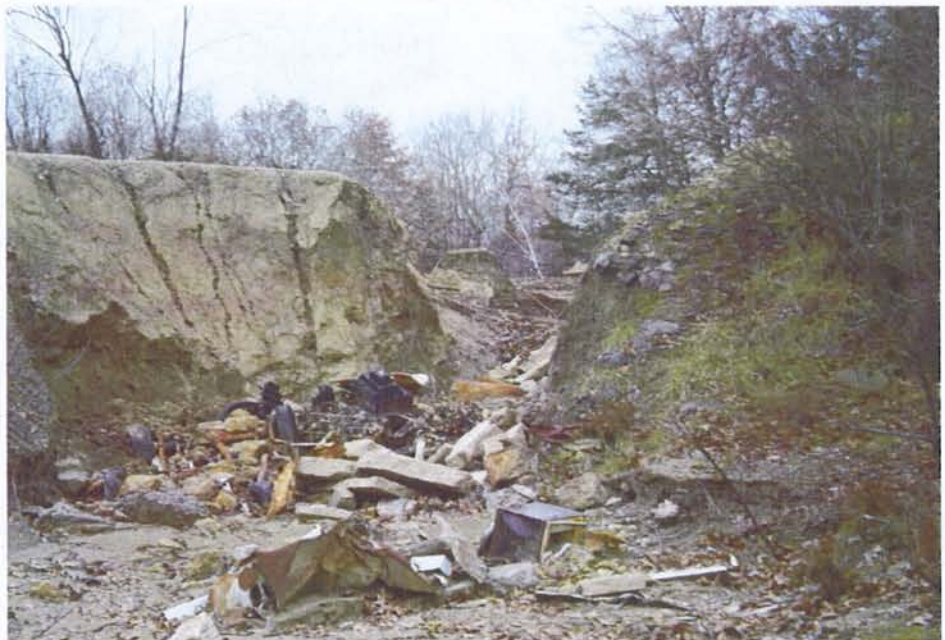
The western boundary of the settling pond is composed of a dam consisting of mine tailings. The dam is estimated to be approximately 20 feet above the surrounding terrain. During the 2009 Expanded Site Inspection, the dam was observed to be broken, possibly due to excess surface water and erosion. The breach in the dam is estimated to be approximately 15 feet wide and 20 feet deep. A photograph, contained in Appendix C, was taken to illustrate the broken dam. West of the dam was evidence that mine tailings had and continues to flow beyond the settling pond. The area west of

Photo taken of the broken berm located along the western boundary of the surface impoundment.

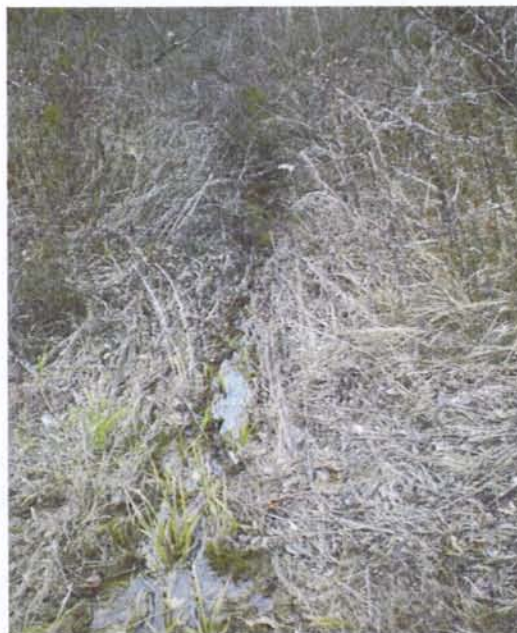
DATE: November 17, 2009
TIME: 1320
PHOTO BY: B. Everetts
DIRECTION: Southwest
COMMENTS: Photo taken of the flow of surface water along the overland flow route that is migrating toward Smallpox Creek. This view is looking toward Smallpox Creek.

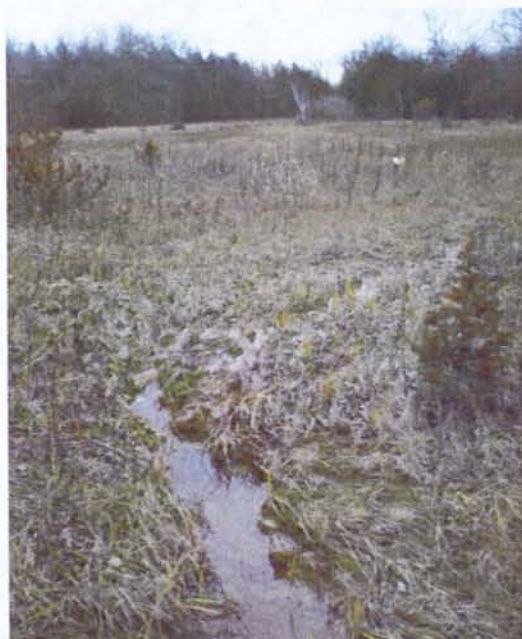
DATE: November 17, 2009
TIME: 1320
PHOTO BY: B. Everetts
DIRECTION: Northeast
COMMENTS: Photo taken of the flow of surface water along the overland flow route leading from the surface impoundment to Smallpox Creek. This view is looking away from Smallpox Creek.

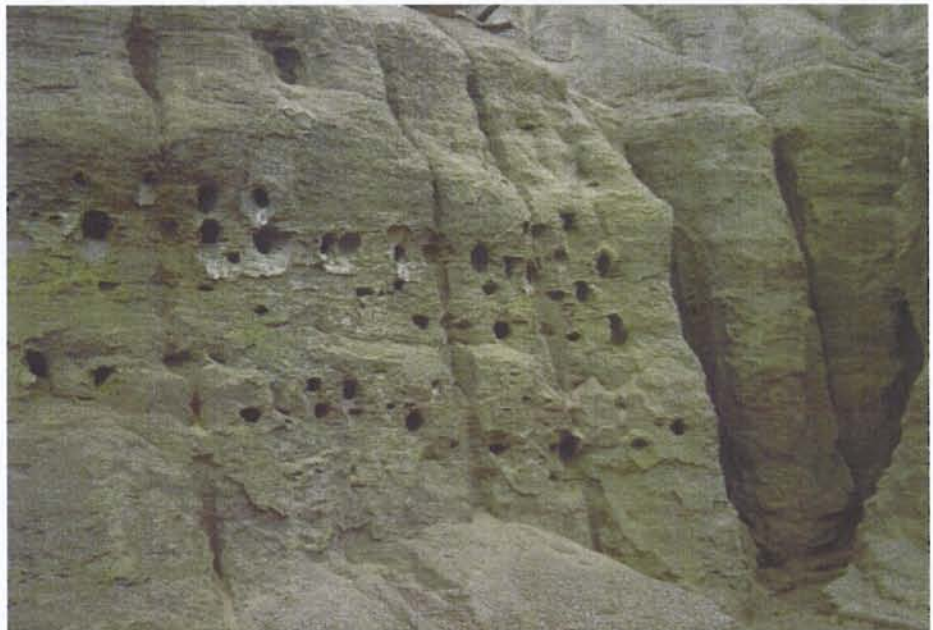
DATE: November 18, 2009
TIME: 1200
PHOTO BY: B. Everetts
DIRECTION: South
COMMENTS: Photo taken of the bird dwellings that have been formed in the side wall of the waste pile.
